Re-Strengthening Brisbane City Hall: A Case Study of Heritage Engineering

**Submitted in fulfilment of the requirements for the degree
of
Master of Applied Science (Research)**

November 2013

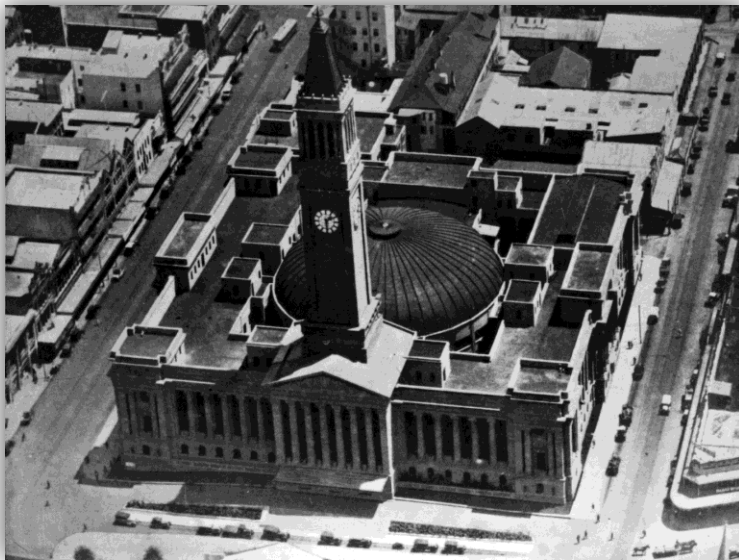
Figure 6 Photograph showing the original condition of the concrete flat roof
(Source: Brisbane City Council)

The main source of water problems that was found came from the roof. A photograph taken a year after Brisbane City Hall opened in 1930, showed the original flat roof (See Figure 6). That physical condition of being flat where water could easily be trapped would be susceptible to maintenance problems. It was recently discovered that the roof was leaking badly due to the limitations of waterproofing system. The major contractor's (ABI Group) project manager, Rod Boxall, explained that they had a problem installing a watertight seal on the surface of the flat roof (Lofthouse, 2011). The floor surface of the rooftop was exposed and it revealed that bitumen membrane was used in the past to protect the floors below from water ingress. The bitumen membrane that was used for waterproofing was originally from Northern Europe where they have a cooler climate. The technology that was used 60 to 70 years ago was not tested against the Queensland climate. However this membrane, once subjected to the harsh climate of Queensland, became relatively brittle. Cracks also appeared in the concrete as structural movement occurred. From the weakest point, the water found its way below the barrier until it reached the steel reinforcement of the structure.

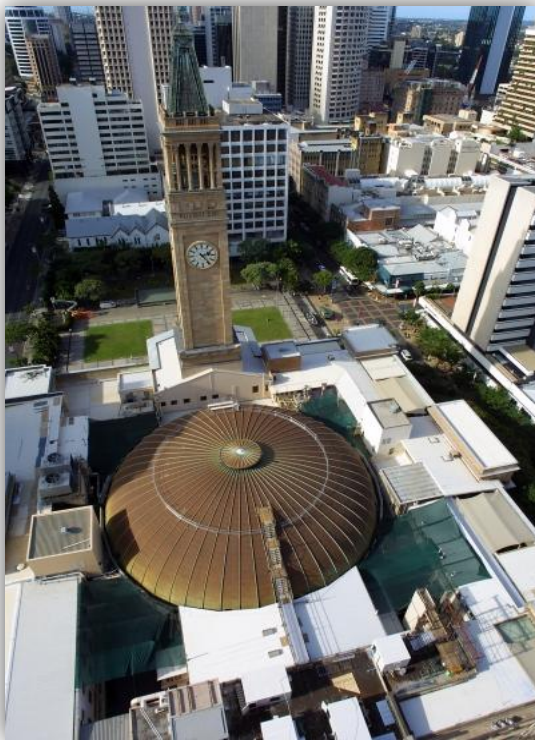
Figure 8 Photograph showing the roof with items that was added over the years (Source: Brisbane City Council)

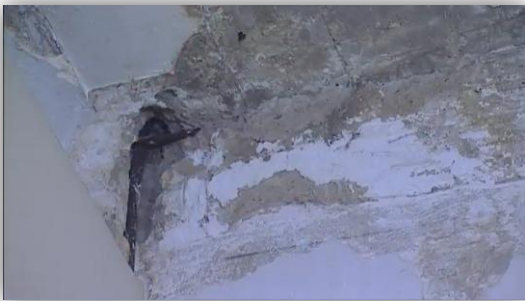
Figure 10 Corrosion of reinforcement on Brisbane City Council structure (Source: The Soul of Brisbane)

The weakening of the steel reinforcement can be traced back to the lack of integrity of the concrete. When the concrete is exposed to chemical and acid attacks, the material characteristically deteriorates, leading to problems with the steel. Reinforcement steel is also vulnerable to chloride and carbonation that in turn cause the concrete to deteriorate. Once reinforcement corrosion is initiated, it progresses at a fairly steady rate and shortens the durability and service life of the structure. The rate of corrosion directly affects the extent of the remaining service life of a corroding reinforced concrete structure. This rapid deterioration is commonly known as 'concrete cancer' (Gebregziabhier, 2008).

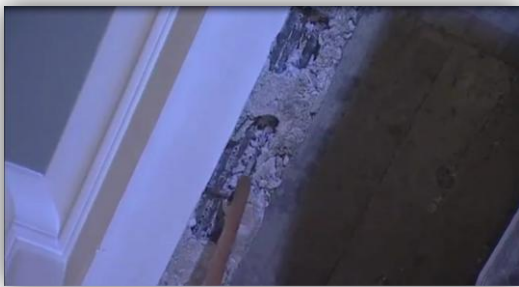
Figure 11 Concrete spalling under the beam of Brisbane City Council structure (Source: The Soul of Brisbane)

strength of the concrete. The sulphate content in the concrete, although low in the area tested above ground, could still be high below ground level because the sulphate content level in the water table also registered as being high (Beal, 2008). This sulphate (salt) chemically reacts with concrete and in addition to expansion of steel due to corrosion cause damage such as spalling of concrete and the loss of concrete cover that in turn expose the reinforcing steel to further deterioration.

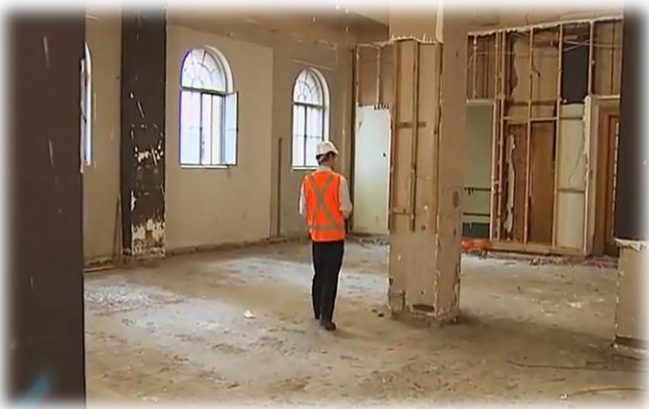
Figure 15 Photograph showing columns that require strengthening (Source: The Soul of Brisbane)

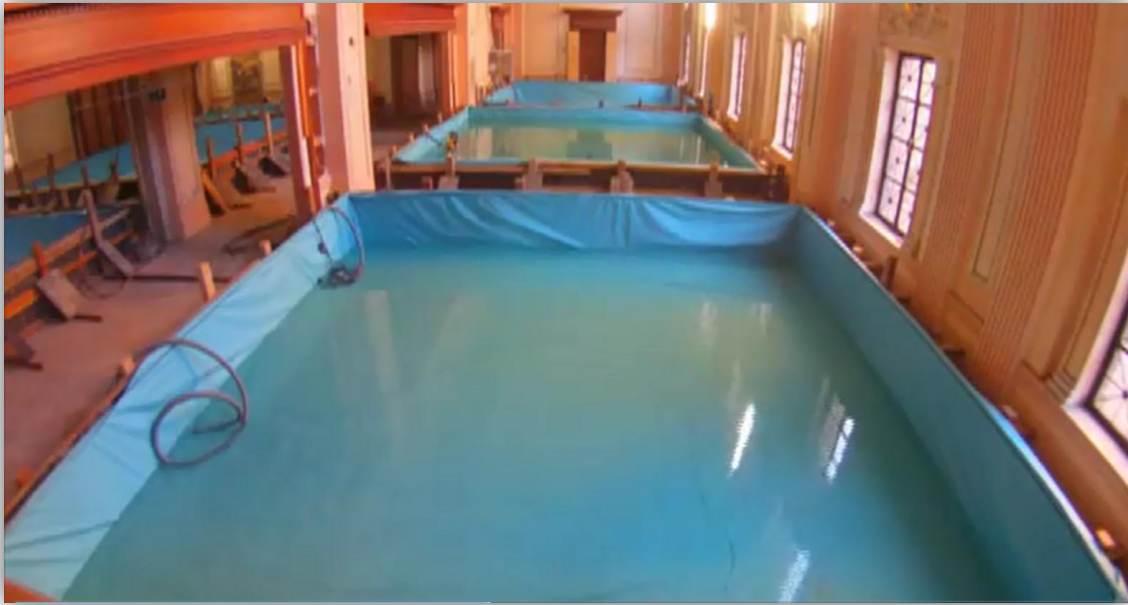
Figure 21 Water tank filled with water to test beam deflection when subjected to load (Source: The Soul of Brisbane)

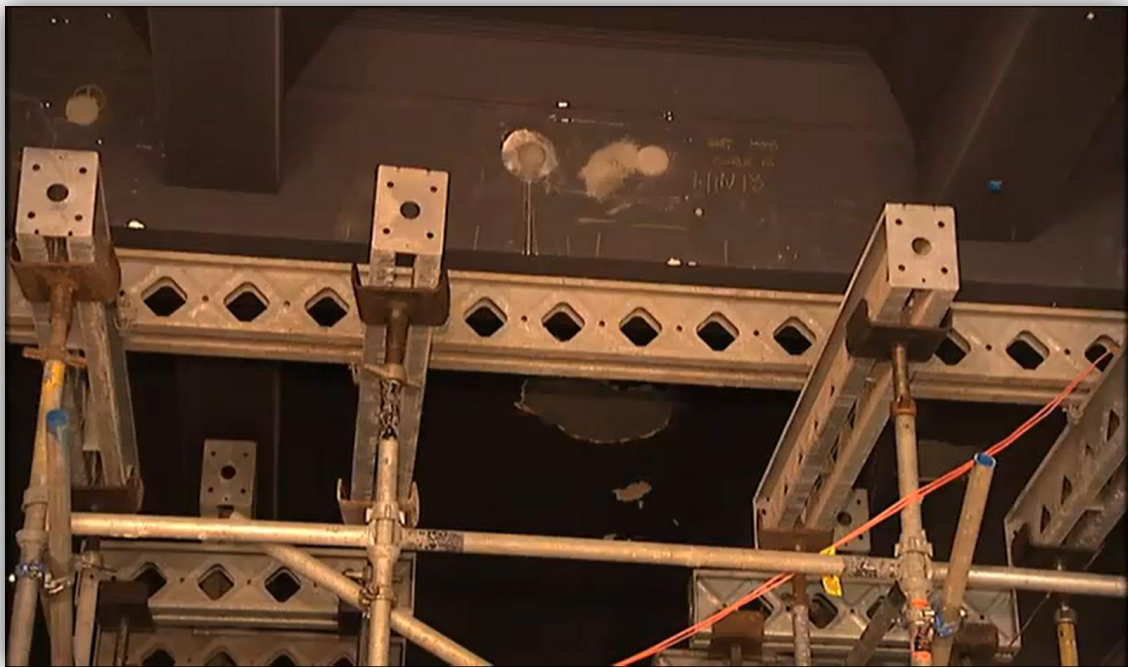
Figure 22 Photograph showing the test of girders under load (Source: The Soul of Brisbane)

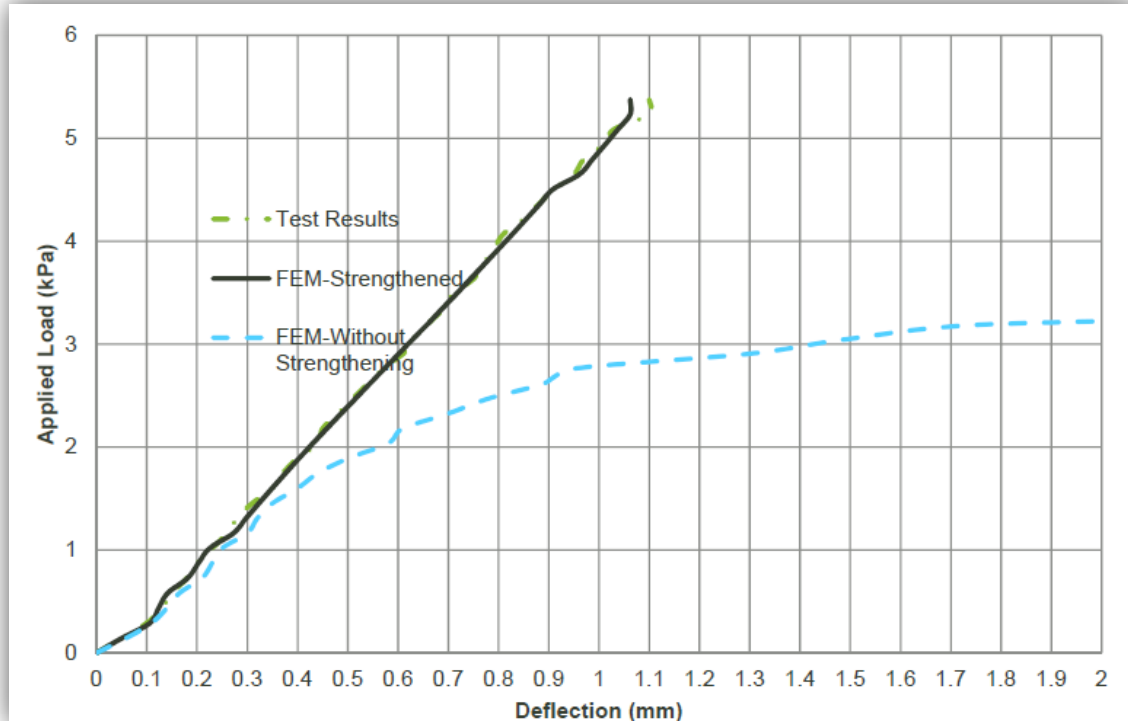
The results of the load test are summarised in Figure 24, which shows the deflection against the applied load for the onsite strengthened girders, along with the theoretical results for both strengthened and un-strengthened girders (both modelled using finite-element analysis).

The full-scale load test demonstrated that the strengthened girders performed in the manner predicted in the theoretical analysis. Based on the results of the full scale

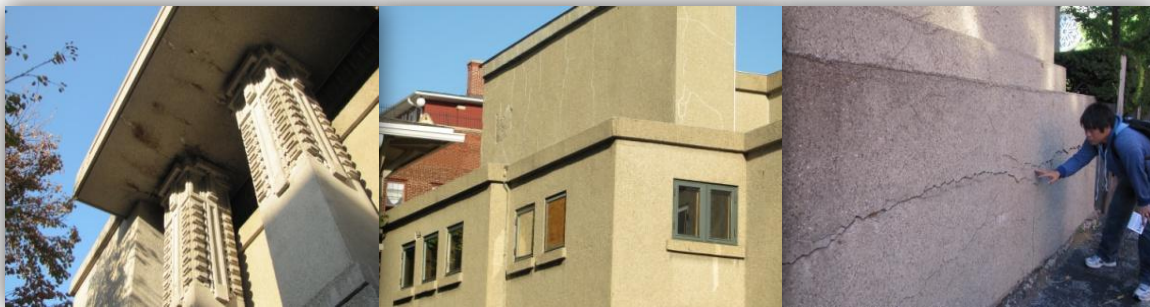
Figure 29 Photographs showing deteriorations of the reinforced concrete structure of Unity Temple (Source: A. Cruz)

Since one of the major materials used in constructing the building was light weight concrete, the deterioration of the steel reinforcement was at a faster rate due to the ease for water to penetrate, allowing quicker carbonation compared to normal weight concrete because the alkalinity is lower than normal weight concrete, resulting in a decline in the integrity of the steel reinforcement.

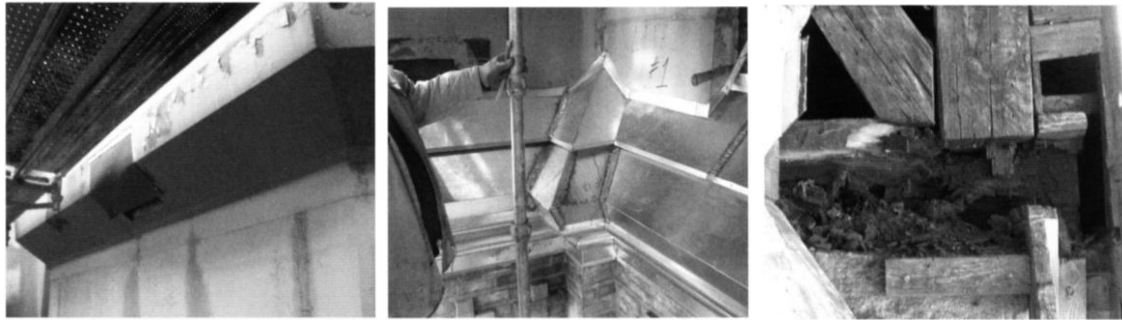
Figure 35 Photographs showing the decay, previous repairs and the new metal waterproof casing for the cornice of the Holy Family Church Bell Tower (Source: Wiss, Janney, Elstner Associates)
